# **Letter Health Consultation**

**FORMER STELLA CARDWELL HOSPITAL  
STELLA, NEWTON COUNTY, MISSOURI**

**EPA FACILITY ID: MON000704954**

**MAY 22, 2008**

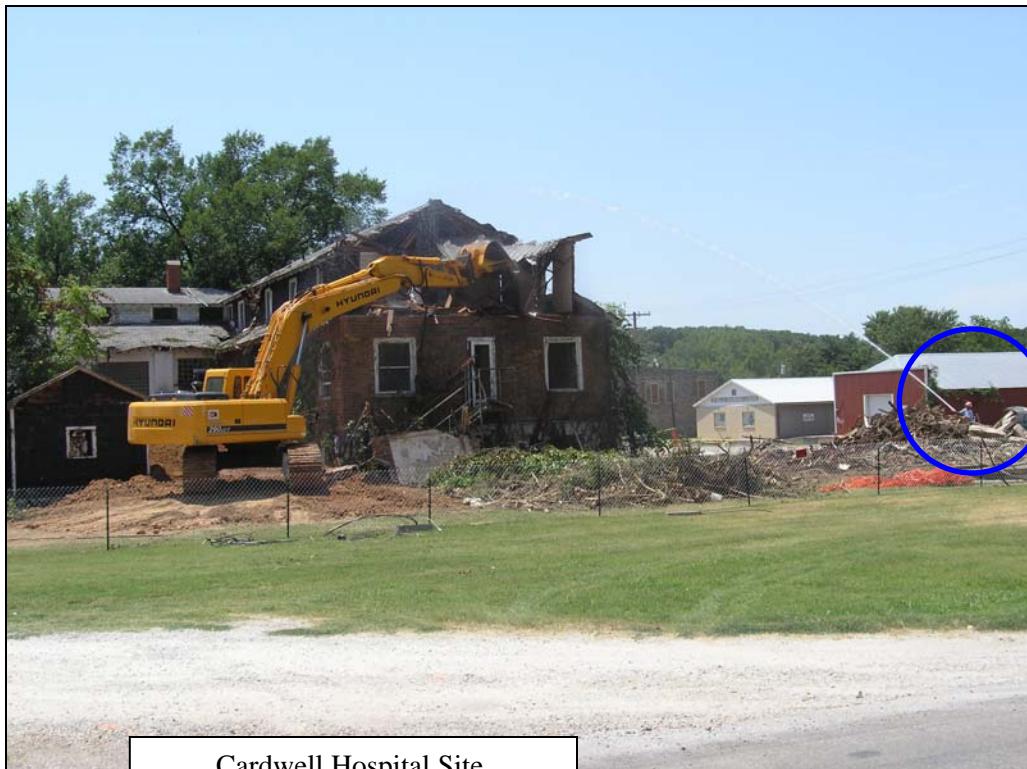
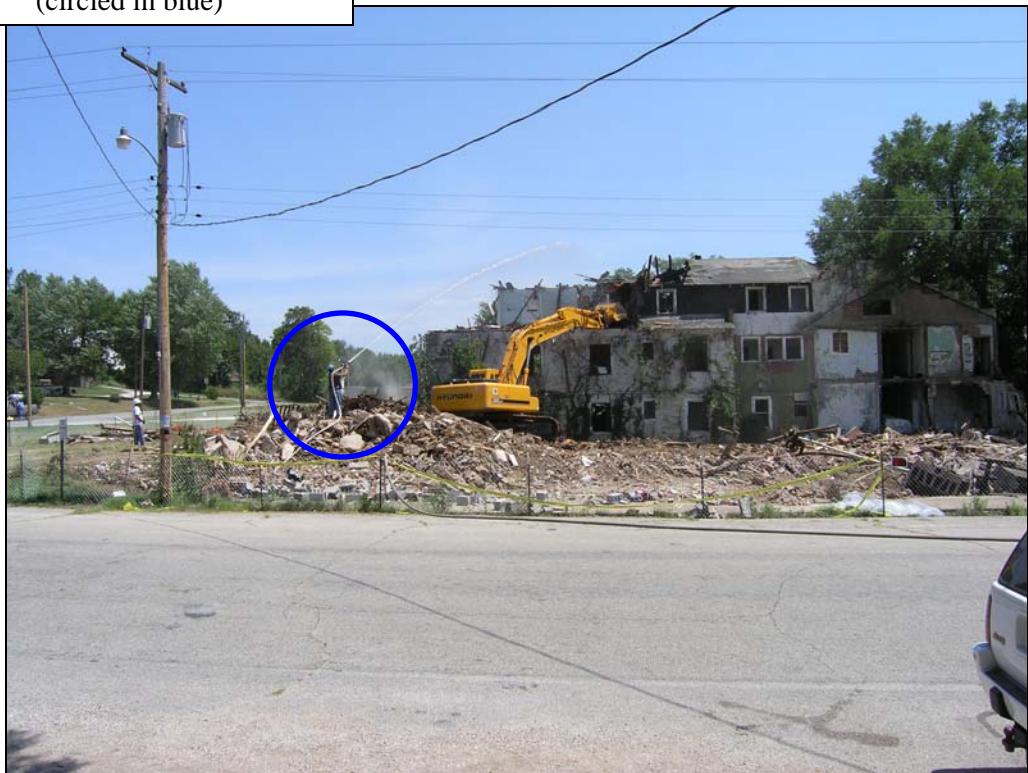
**Figure 3**  
Cardwell Hospital Building Demolition, Dust Suppression  
Cardwell Hospital Site  
Stella, Missouri

Cardwell Hospital Site,  
Dust suppression application.  
(circled in blue)

The EPA contractors took several steps to ensure that asbestos fibers or dust contaminated with lead based paint were not released from the site above levels of health concern during the clean up actions. Removal of ACM inside the building was primarily conducted within four constructed plastic enclosures under negative air pressure to ensure that asbestos fibers were not released outside of the building. Non-friable transite siding was kept wet and was carefully removed from the exterior of the building to minimize breaking. For the portion of the building that was structurally unsound, EPA contractors employed a wet-demolition technique to keep air emissions to a minimum. Finally, as the remainder of the building was demolished, a water spray was continually used to suppress fugitive dust (3). See Figure 3.

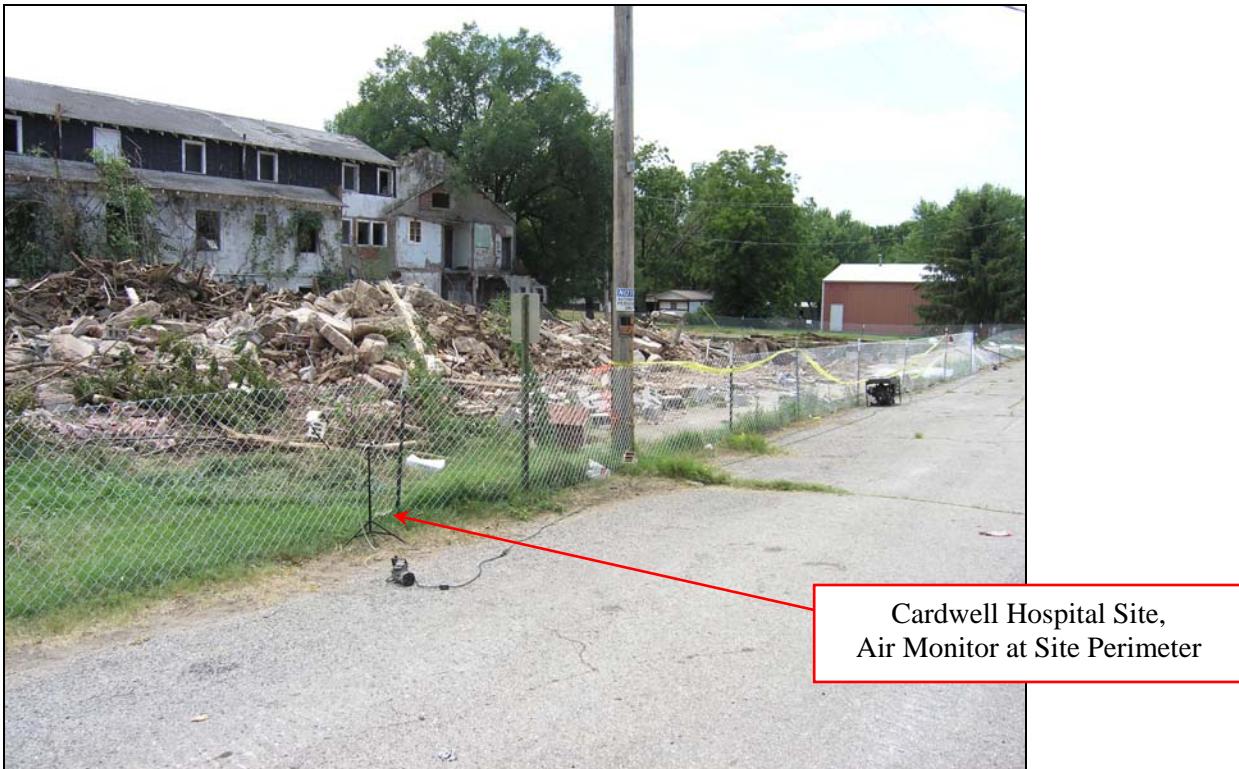
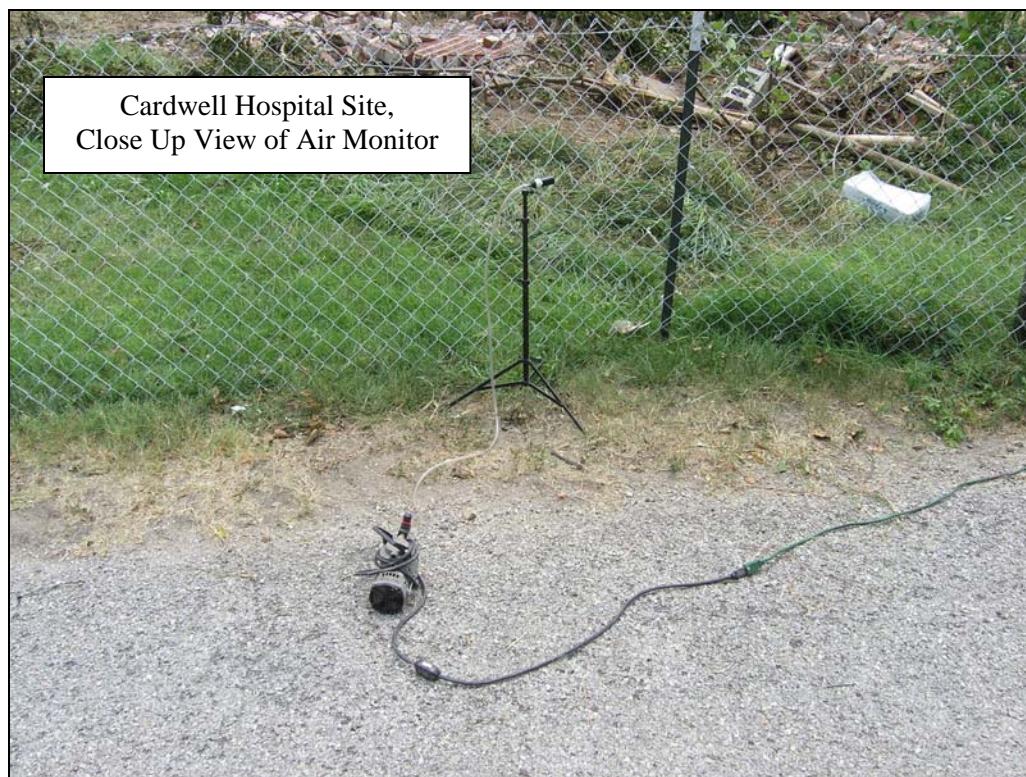
**Figure 4**  
Cardwell Hospital Building Demolition, Perimeter Air Monitoring  
Cardwell Hospital Site  
Stella, Missouri

Air samples were collected during and after asbestos abatement activities and demolition of the building. A total of 9 air samples were collected at the perimeter of the site during asbestos abatement. The concentration of asbestos in one sample was reported by the laboratory as less than 0.03 f/cc, but all others were 0.01 f/cc or less. A total of 15 air samples were taken during asbestos abatement right at the work areas. The highest concentration of asbestos at these locations was one sample that showed 0.05 f/cc asbestos in air; the other sample results were 0.01 f/cc or lower. Finally, 18 air samples were also collected in areas of the building where abatement was complete to verify that asbestos did not remain in ambient air. Three of these samples were above 0.01 f/cc, including one sample at 0.21 f/cc. The remainder of the samples were all below 0.01 f/cc. The three samples above 0.01 f/cc were believed to be associated with removal of exterior asbestos-containing siding very near the interior sample collection point. Corresponding background air samples at the site perimeter that day showed asbestos levels of 0.004 f/cc or less, indicating that the exterior siding removal may have created localized elevations of asbestos concentrations, but did not contribute to significant levels of asbestos migrating off site (3).

In addition to these removal techniques to prevent a release of asbestos fibers from the site, EPA contractors also conducted ambient air monitoring (Figure 4) to verify that asbestos or lead paint dust was not leaving the site above levels of health concern (3). The Occupational Safety and Health Administration (OSHA) has established a level of 0.1 fibers per cubic centimeter (f/cc) as the limit for workplace exposure to asbestos (2). EPA contractors took action to reduce asbestos levels in air if the concentration of asbestos rose above 0.01 f/cc (3). The EPA has established a residential health-based benchmark of 0.0009 f/cc in indoor air (4). However, this benchmark does not apply to the short exposure time potentially experienced by individuals at the former Cardwell Hospital site during clean up actions by EPA.
